I-5 and East Duwamish Greenbelt

CONDITIONS ASSESSMENT

February 17, 2016

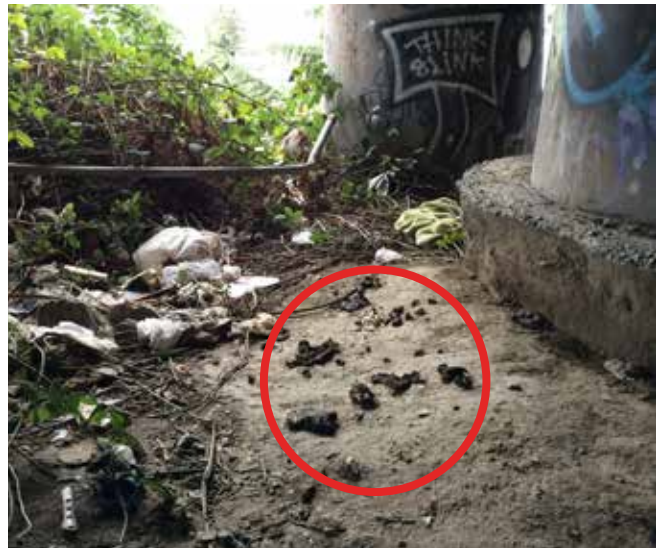
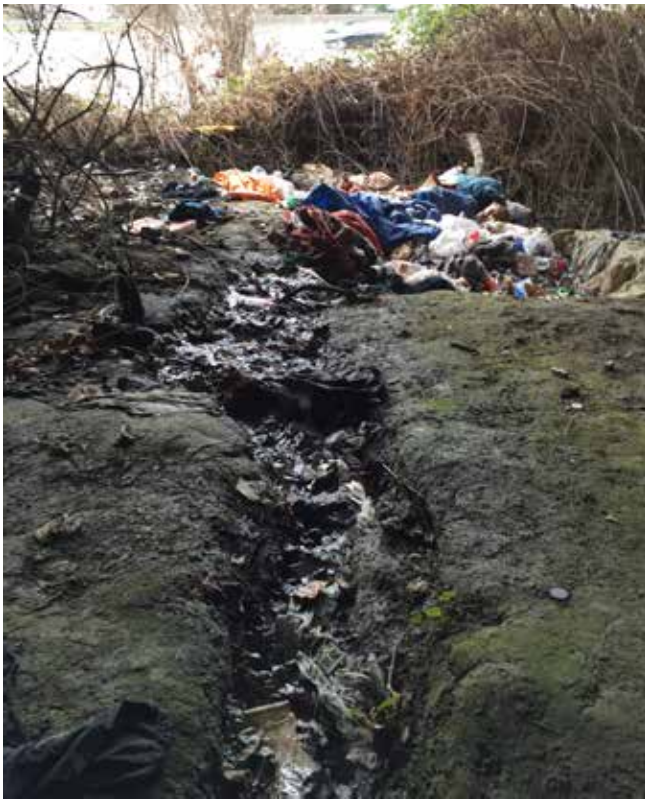
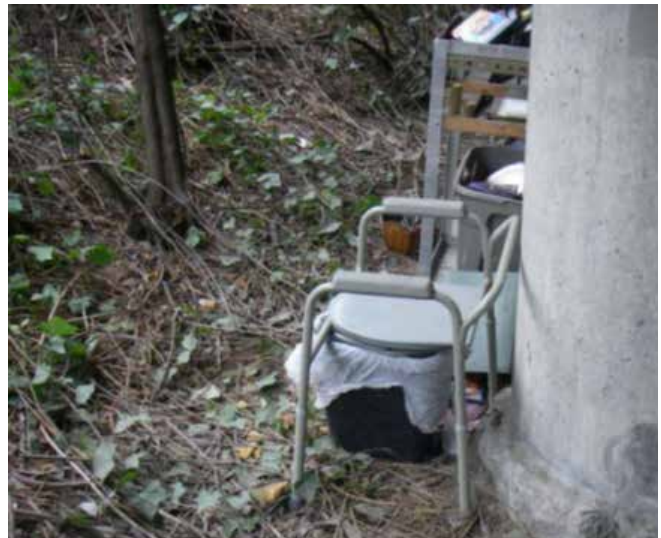
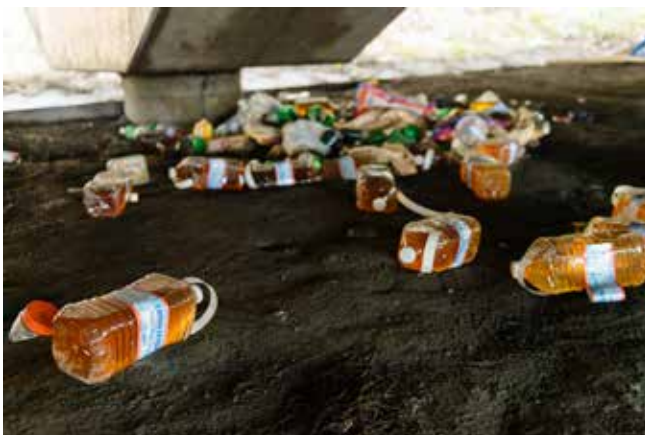
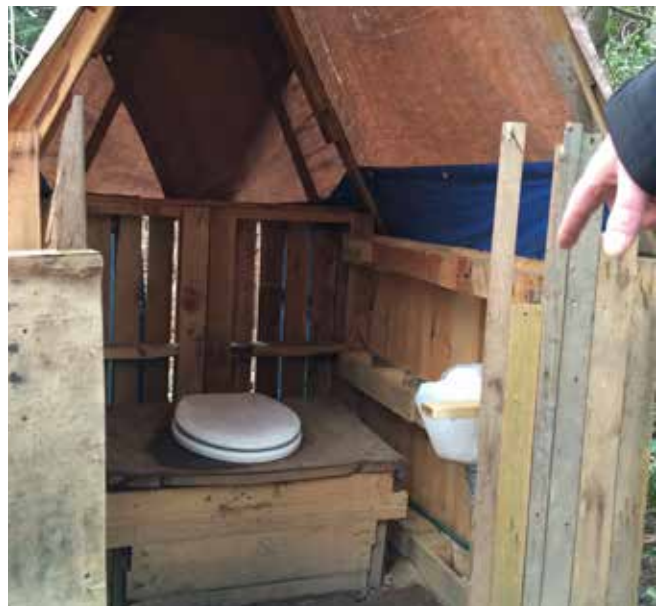
With more than 200 campsites, and potentially more in areas not immediately obvious on the initial walkthrough, one of the most significant challenges is the lack of hand washing facilities and sanitary toilets. The area does not have running water or sewer infrastructure, and so waste disposal is handled in several different ways. Some campers had obvious areas and containment for defecation (buckets and homemade latrines), however there was no designated location where these toilets could

be emptied into a sanitary sewer. As a result most human waste appears to be dumped on the ground away from encampment sites. In some cases, however, feces and jars of urine lay in close proximity to living quarters. The team did document one pit toilet and urinal on the top of a steep slope.

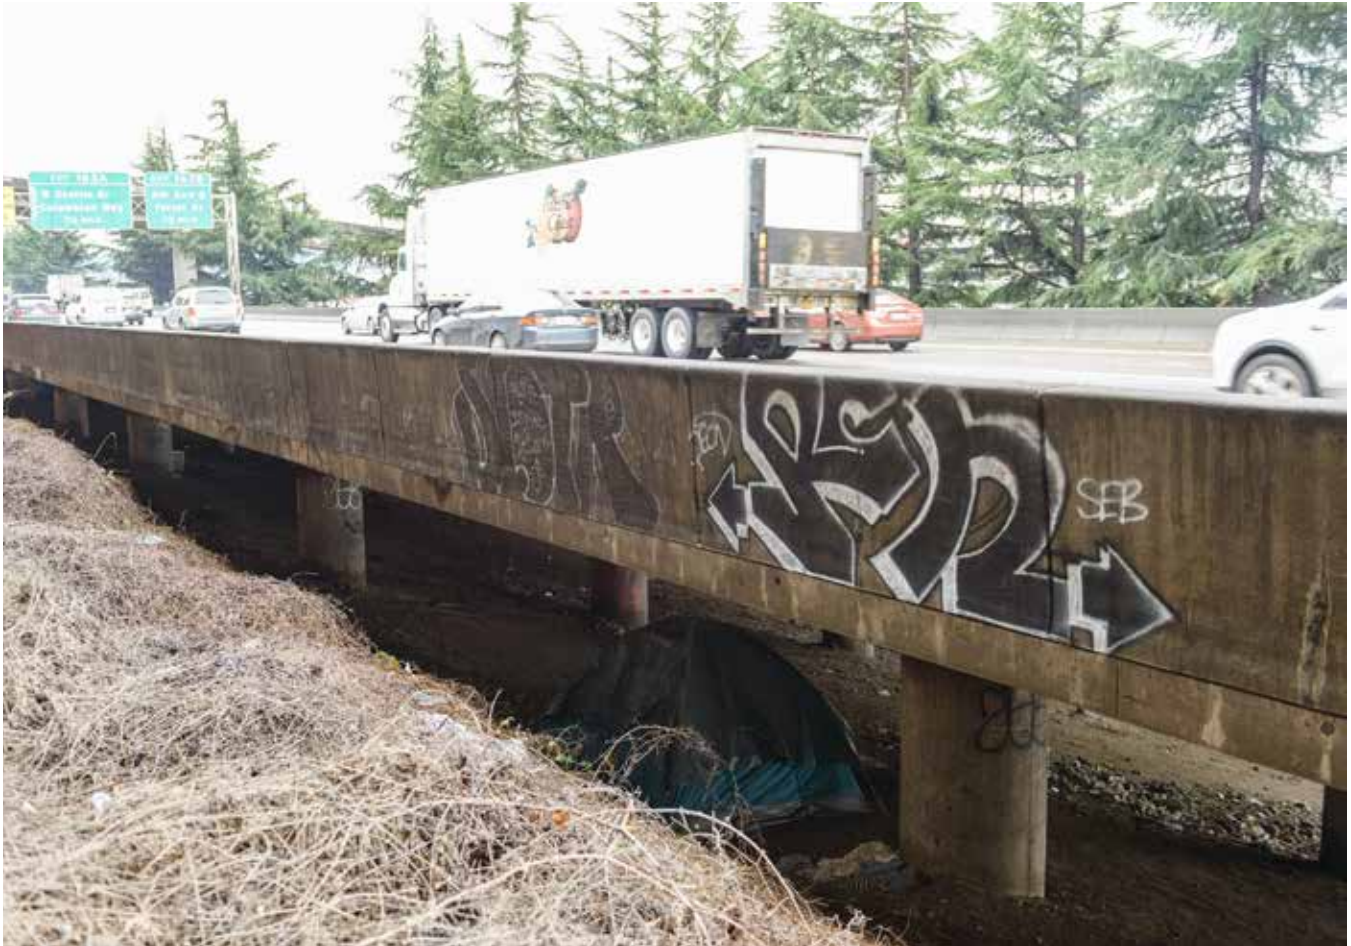
4 Infrastructure

The section of I-5 through the area is almost entirely elevated on support columns in both the north and southbound lanes, effectively two three-mile bridges. The shelter provided by the freeway makes the area particularly attractive to those seeking cover from the elements. But because of the density of encampments and waste accumulation, the freeway structure is difficult for maintenance workers to access in many locations. Washington State Department of Transportation staff report serious challenges conducting routine scheduled maintenance due to debris and criminal activity. While deferred maintenance is a problem, this area is even more vulnerable because there has been added

damage to the structure from the adjacent encampment activities. The open sewers, solid waste accumulation, and fires, have caused excessive water ponding and large burns that have superficially damaged the underlying freeway concrete.

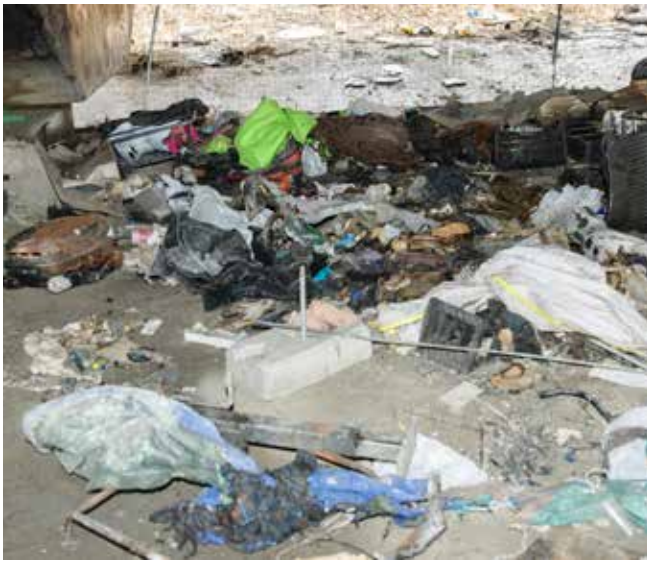
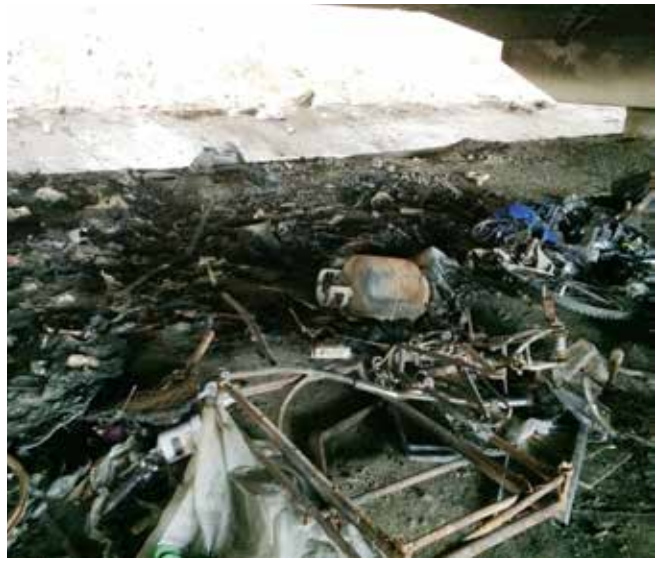
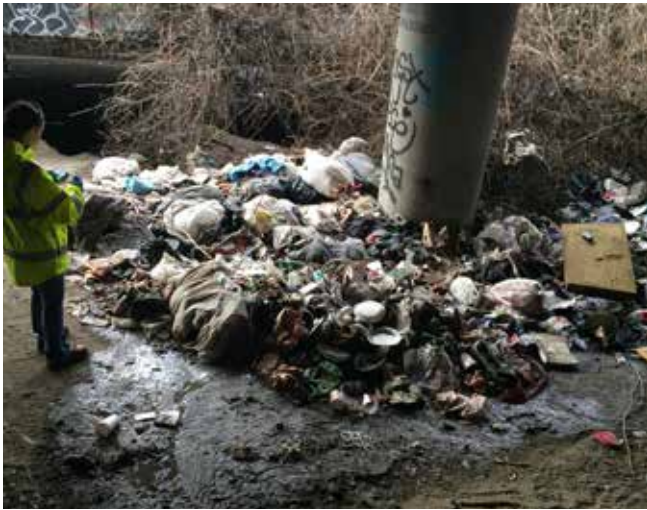
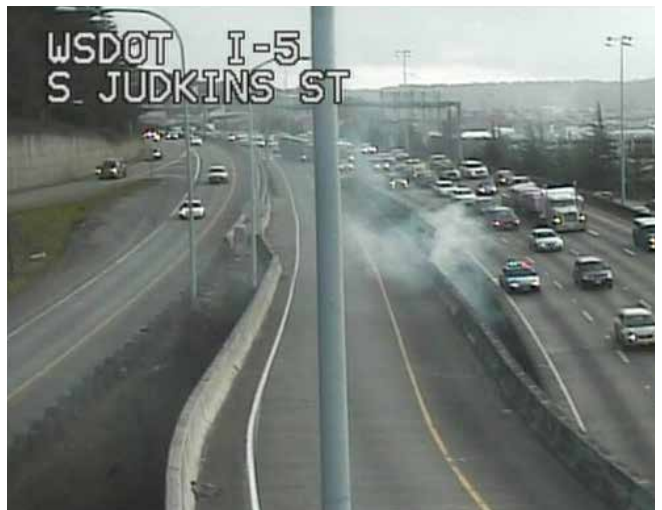
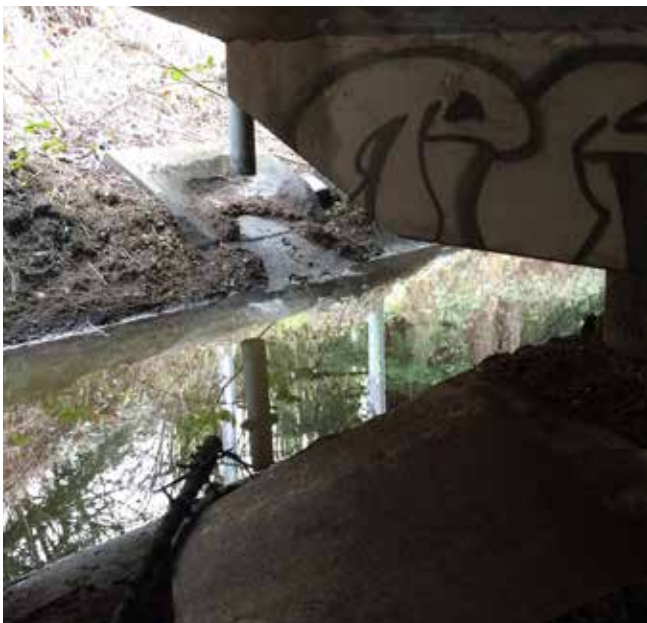
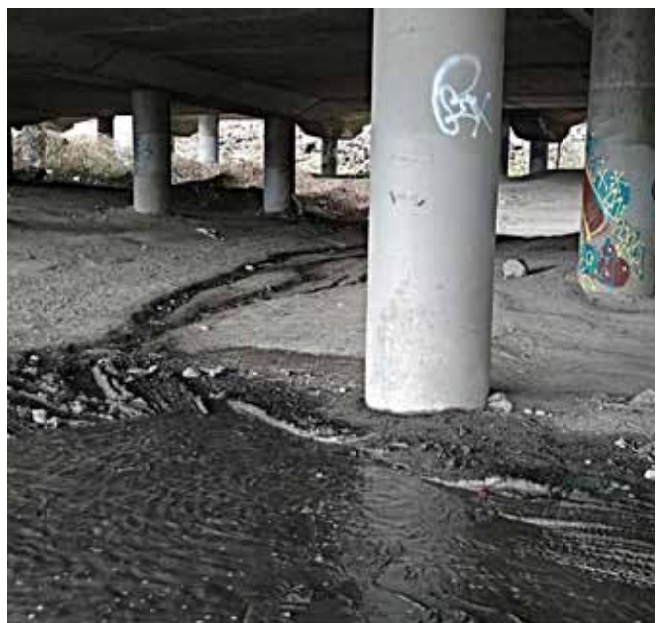
The most prevalent infrastructure threat posed by the encampments is fire. The joint assessment team saw dozens of campfire pits and several large burn pits. Two sites in particular were host to large-scale fires in the past four months that included high volumes of trash, bicycles, scrap metal, and propane tanks. These fires required

Seattle Fire Department response, shut down portions of the freeway, and resulted in visible but superficial damage to the concrete under-side of the interstate structure.

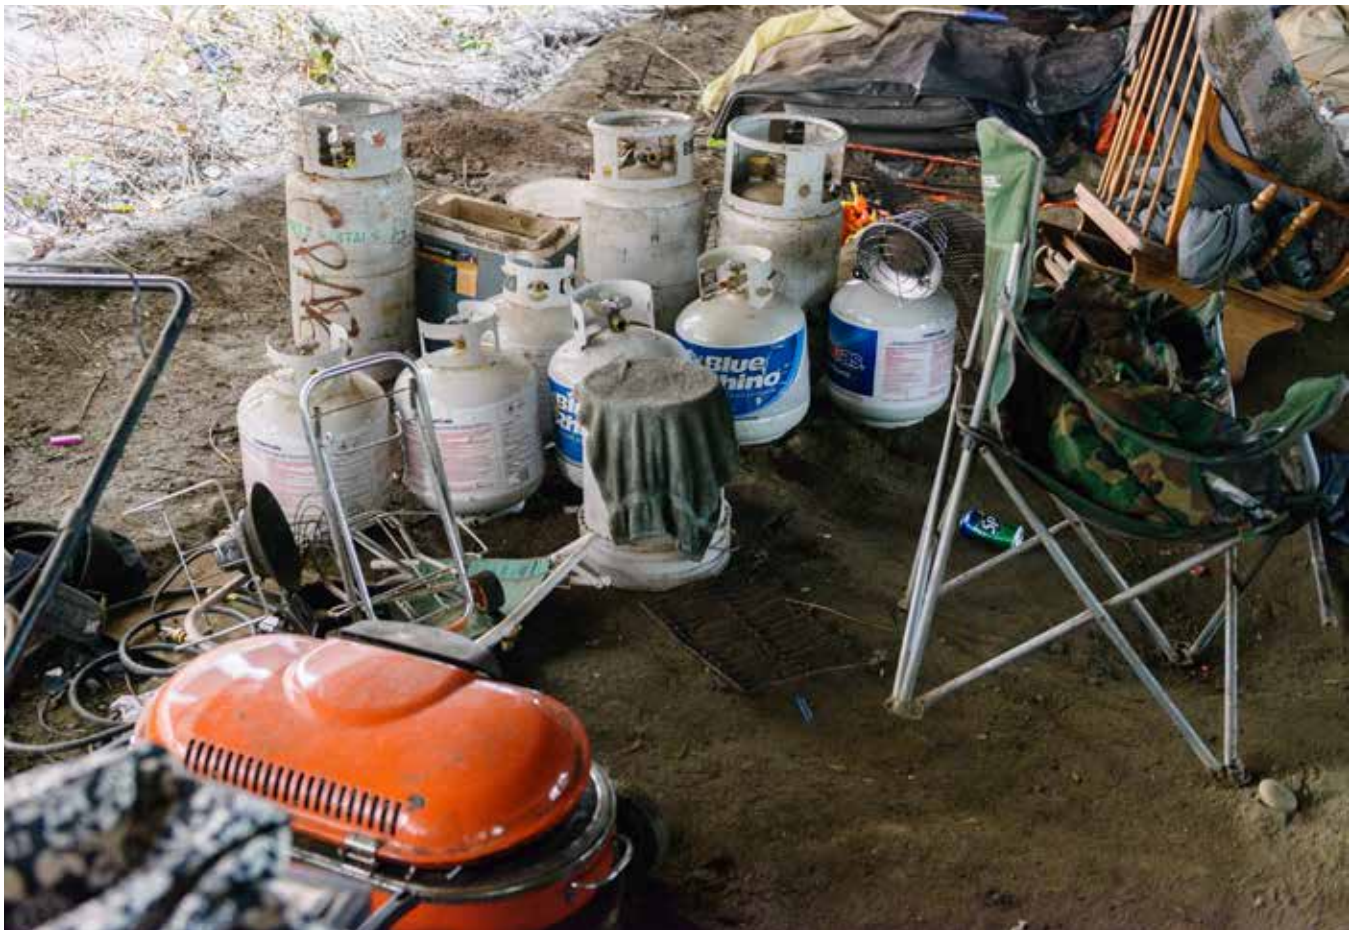
The storm water system under I-5 is owned by the Washington State Department of Transportation and is the primary way to facilitate drainage from the interstate. Drains from the freeway are directed through downspouts and either discharge into open drains or are directly connected to a large storm water pipe, which ultimately discharges to the Duwamish Waterway. The joint assessment team observed:

- Catch basins and mainline manholes that were buried or full of garbage and debris
- Catch basins that were missing covers
- Several blocked downspouts that were crushed or otherwise inoperable

Damaged drain pipes can cause freeway runoff to discharge directly into the ground, rather than into the storm water system. In some places, areas around the footings of support columns had been dug out by area residents to divert water.

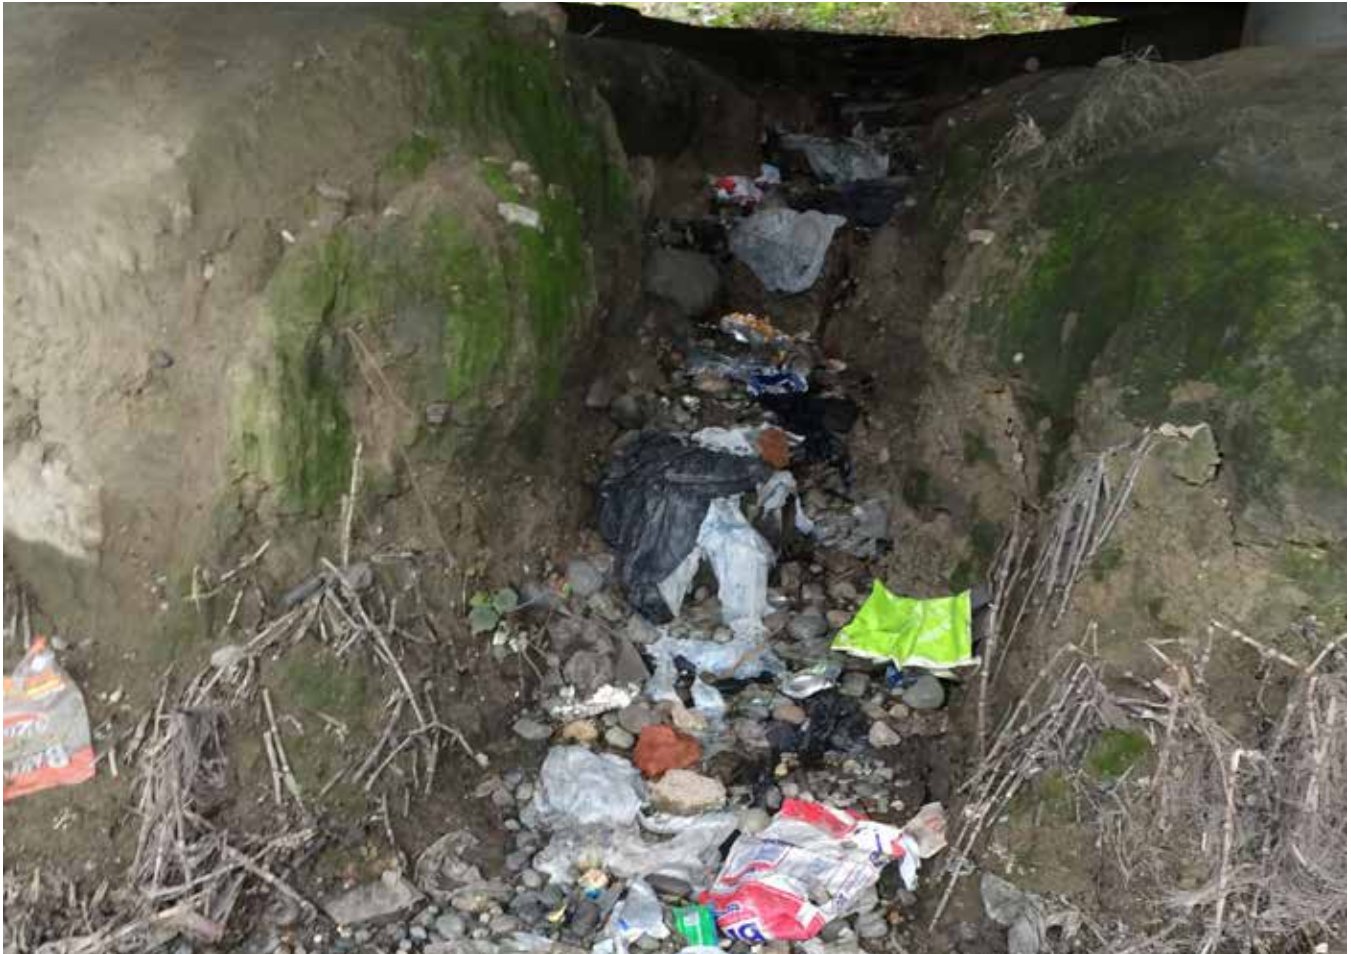
5 Environment

Water from I-5 and the adjacent wooded areas flows into storm drains that go directly into the Duwamish River and then into Puget Sound. To better understand the potential down-stream water quality issues, Seattle Public Utilities examined the water run-off and soil quality within the assessment area. As noted above there were indications of sewage disposal into catch basins and open drainage. In one case, a resident built a makeshift bathroom, which included a toilet seat over a bucket and a urinal made with a pipe that discharges to the open drainage ditch. Piles of trash were located up gradient of catch basins. Clearly visible in the trash were batteries, electronics, syringes and liquid wastes. These

materials are likely discharging directly into the storm water system during rain events. This issue is exacerbated by the fact that the catch basin grates and outlet traps were missing in several areas. Camp “kitchens,” including dishwashing and clean up areas, were also present and a possible source of pollutants to the drainage system.
