SEATTLE PUBLIC UTILITIES
WATER SYSTEM SEISMIC STUDY
SUMMARY REPORT
2018

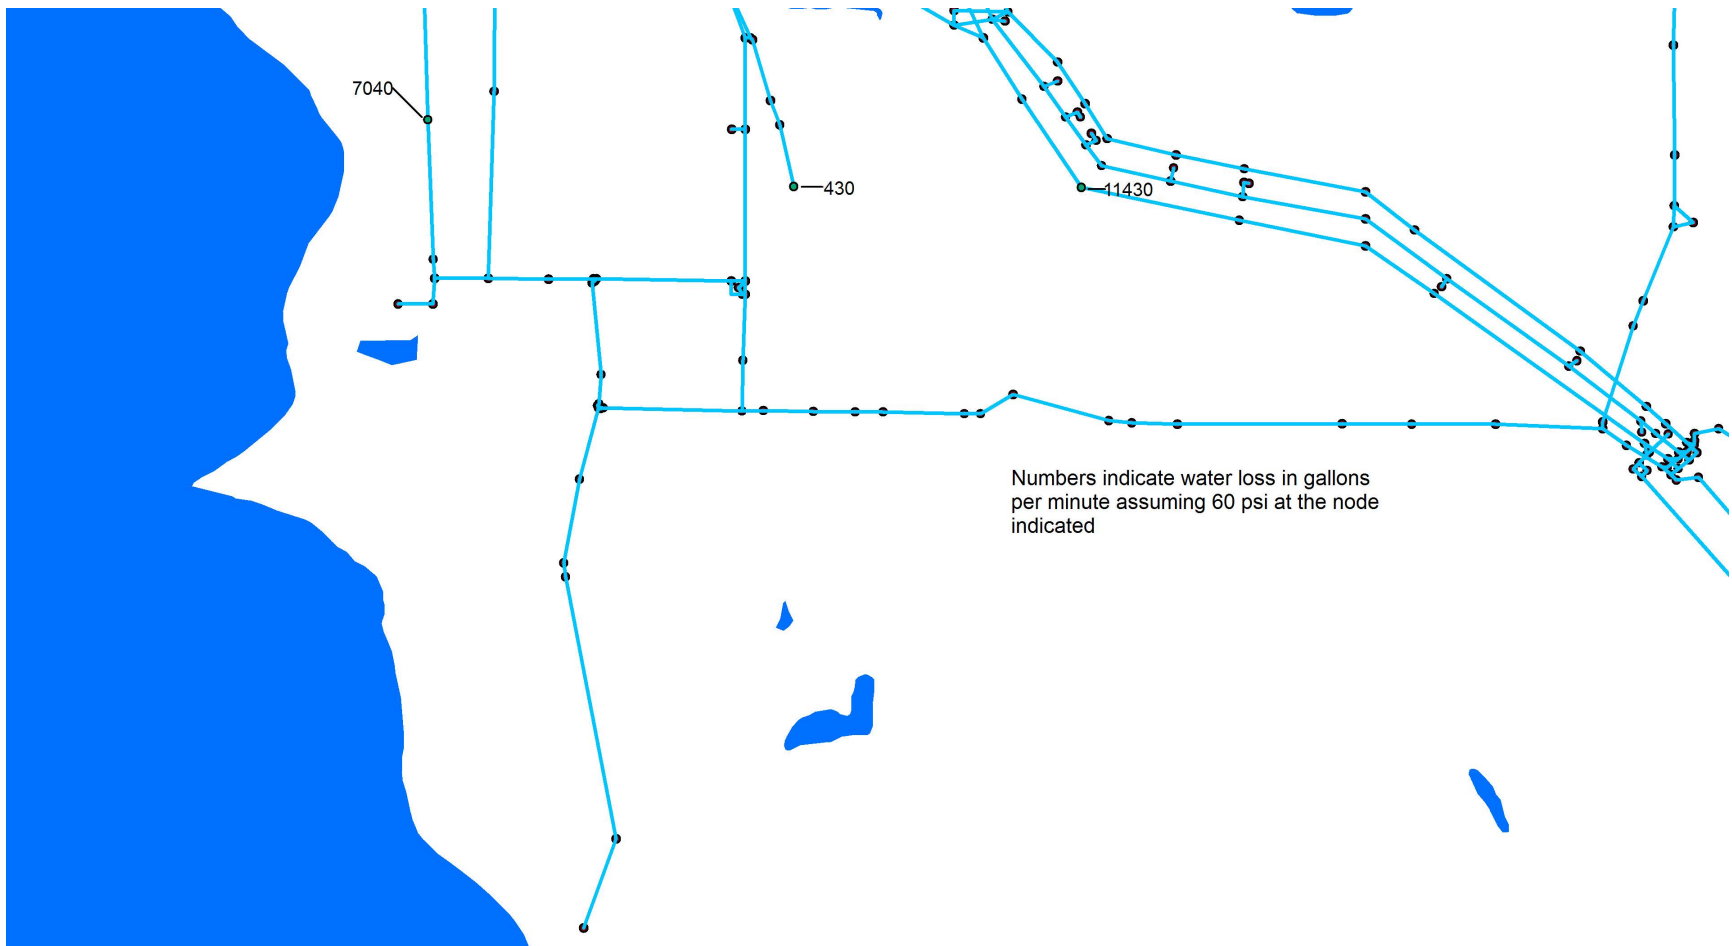
Figure 5-5. Water loss (gpm) at 60 psi for M7.0 SFZ scenario (southern direct service area)

The aggregated water loss values were then assigned to representative nodes in the SSRA model that most closely matched the node(s) the aggregated pipe failure would affect. The water loss in gallons per minute (gpm) at 60 psi, and assigned locations (SSRA model nodes), are shown on Figures 5-2, 5-3, 5-4, and 5-5 for the M7.0 SFZ scenario. The water losses
