## Landmarks Preservation Board

### REPORT ON DESIGNATION

LPB 271/12

Name and Address of Property: Seattle National Bank Building  
720 Second Avenue

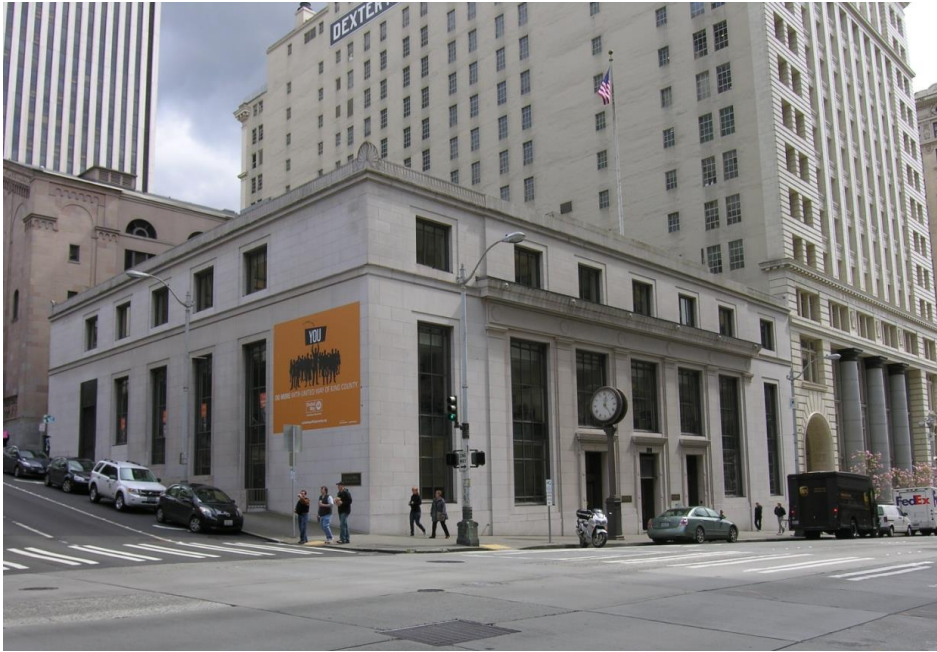
Seattle National Bank Building, 720 Second Avenue, 2012

The reinforced concrete structure is three stories in height with a full basement level and measures 120 feet by 108 ft. It is clad with a plain smooth marble that is a cold grey-white color. The enframed block façade is divided into seven structural bays; it is distinguished by a main two-story central section that is bracketed by narrow end bays and surmounted by a third floor level cap, which form a nearly continuous wall plane. The plane is punctuated by tall, narrow window and window/door bays at the base and square window openings at the cap that reinforce classical design elements. These crisply cut openings and the simplified and finely detailed architectural elements create a refined modern yet somewhat severe appearance. This severity in combination with refined classical motifs serves to convey strength and stability and reinforces the public image desired for a banking institution.

The base is accentuated by three central entry bays; each composed of a slightly recessed entrance vestibule surmounted by a large rectangular mezzanine level window. Original sets of decorated, bronze-framed and glazed entry doors remain in place with original granite sills/steps. The doors are trimmed by ornamental cast iron decorated with geometric patterns and meander bands. Finely detailed, bead-and-reel mouldings surround the entrance door openings, which are capped by egg-and-dart and acanthus leaf header caps. The entrance bays are flanked to each side by tall two-story windows and surmounted by an intermediate cornice decorated with carved lions' heads. The window and door bays are accentuated by simple Roman-inspired pilasters that correspond with the intermediate cornice forming the principal façade design element. Originally the bank name "The Seattle National Bank" was carved into the cornice frieze; however, the frieze is now only a simply decorated flat band.

This principal façade element is enframed by tall two-story windows and a third floor level band of windows. Narrow horizontal marble moulding accentuates the third floor level and defines the terminal parapet, which is decorated with subtle fluted patterns and accentuated at each corner with acroteria. The parapet is slightly stepped at the center of the façade.

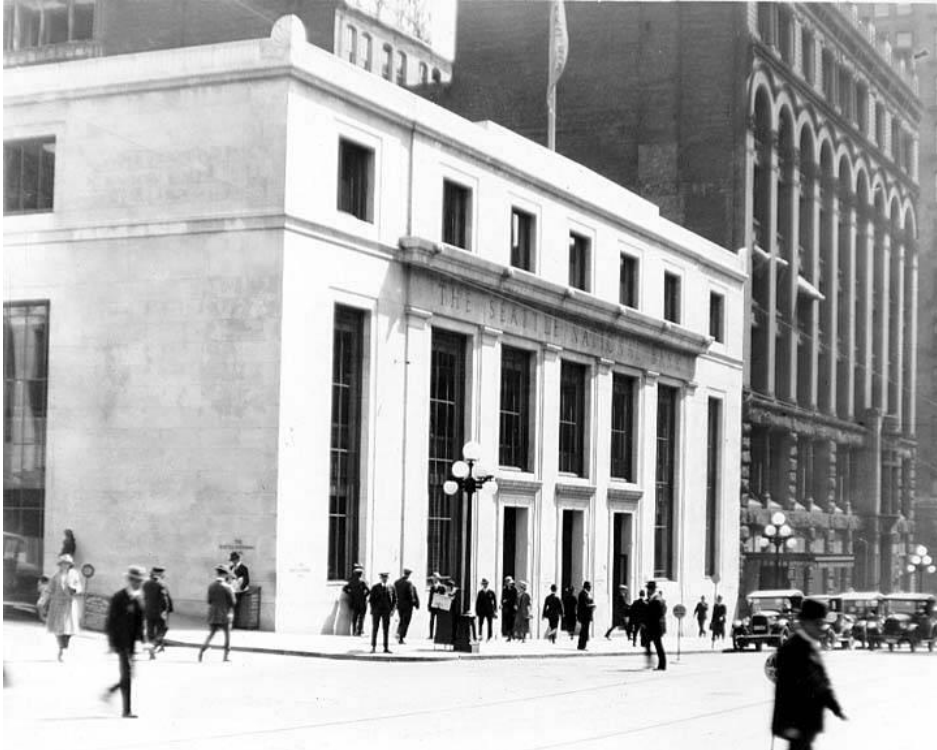
Seattle National Bank Building, 720 Second Avenue, c. 1922

The bank could not begin demolition or construction work until March of 1921 when all of the Boston Block tenant leases had expired. The construction cost was identified as \$500,000 with significant expenses associated with the acquisition of marble products. The new building was completed and formally opened to the public in early August 1922. Press coverage emphasized the simplicity and “air of quiet dignity” of the design:

“The exterior is simple, its lines being of classical architecture, graceful in their expression of strength and solidarity. The walls are of warm pink-toned Tennessee marble and the principal entrances are portals of striking design.”
